New Hampshire Volunteer Lake Assessment Program

2002 Bi-Annual Report for Crystal Lake Gilmanton

NHDES Water Division Watershed Management Bureau 6 Hazen Drive Concord, NH 03301

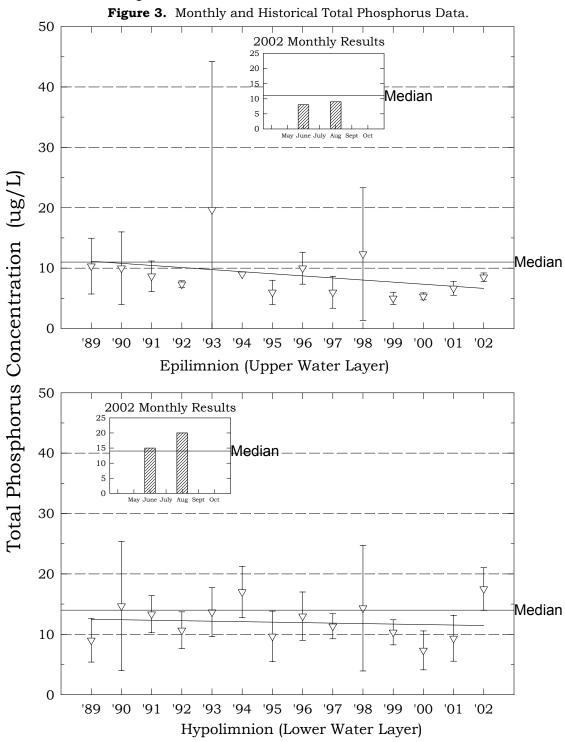
The current year data for the epilimnion (the top inset graph) and the hypolimnion (bottom inset graph) show that the total phosphorus concentration *increased* from June to August.

The historical data show that the 2002 mean epiliminetic total phosphorus concentration is **slightly less than** the state mean.

The historical data show that the 2002 mean hypolimnetic total phosphorus concentration is **slightly greater than** the state mean, and is the **greatest** annual mean since monitoring began in 1989.

Overall, the statistical analysis of the historical data show that the total phosphorus concentration in the epilimnion (upper layer) and the hypolimnion (lower layer) has **not significantly changed** (either *increased* or *decreased*) since monitoring began in **1989**. Specifically, the total phosphorus concentration in the epilimnion and hypolimnion has remained **relatively stable**. (Note: Please refer to Appendix E for the statistical analysis explanation and data print out.)

One of the most important approaches to reducing phosphorus loading to a waterbody is to continually educate watershed residents about its sources and how excessive amounts can adversely impact the ecology and value of lakes and ponds. Phosphorus sources within a lake or pond's watershed typically include septic systems, animal waste, lawn fertilizer, road and construction erosion, and natural wetlands. If you would like to educate watershed residents about how they can help to reduce phosphorus loading into the lake/pond, please contact the VLAP Coordinator.
